## THE ALEPPINE OTTOMAN 'AJAMI ROOMS, DESTRUCTION AND RECONSTRUCTION

Key words: Ottoman cities, Aleppo Heritage, 'ajami Rooms, Syrian conflict

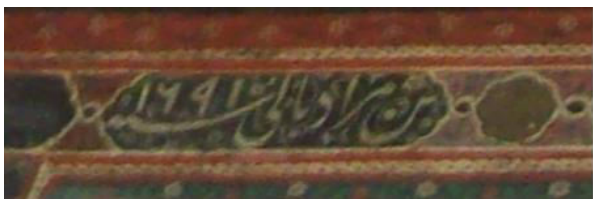
Figure 2: Northern room ceiling (1691AD/1102AH), Rami, 2006

This 17th century building [12] is located in the extramural *Aljdayda* Quarter [13] and was built by *Khajadour Bin Murad Bali* in 1691 A.D./1102 A.H., as inscribed in the northern room ceiling (Figure 4). Later, the Christian family *Saba 'Aidaa* lived in this house in 1737 A.D./1150 A.H. (Figure 5), followed by the Ghazaleh family [14] (also Christian); there were more than 45 people living in the house in 1834 A.D./1250 A.H. (Figure 6). In 1880AD, the upper floor was built which was dated on the carving stone (figure 7). Since 1914, the Ghazaleh House was used as a public school; first converted into a German and then an Armenian school (Haigazian Varjaran). By 2007, the Aleppo Antiquities and Museums Directorate had refurbished the Ghazaleh House, transforming it into a historical museum for the City of Aleppo. In conjunction with this endeavor, from 2009 to 2011, they restored its 'ajami panels.

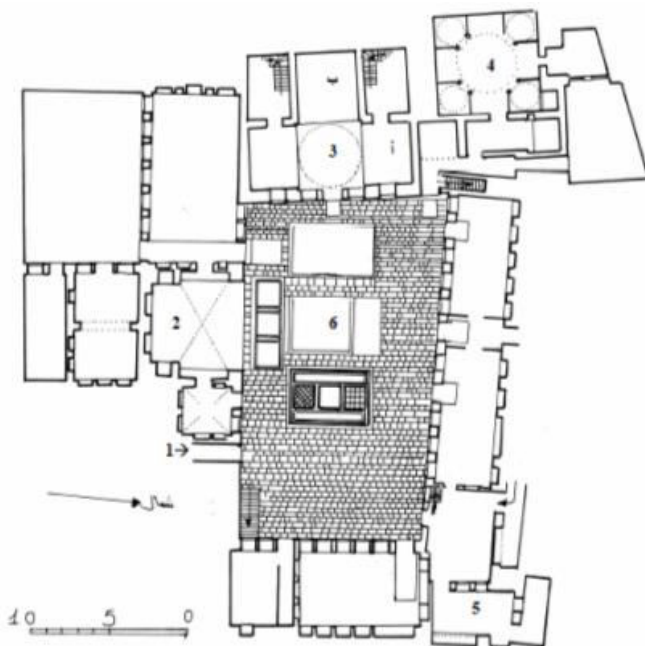
Figure 8: Ghazaleh plan, Burabeh.

The current plan of the house (1000m<sup>2</sup>) contains three courtyards surrounded by two levels of rooms (ground and upper floors) and underground facilities (Figure 8): cellar and cave for keeping food, and the upper floor, *haramlek*, specified for women, which was built later. The size of the biggest courtyard, *selamlık*, is 260m<sup>2</sup> and has an *iwan* and *qa'a* (Figure 9). The second courtyard is 80m<sup>2</sup> and was used to supply food to the kitchen, while the third courtyard, of 25m<sup>2</sup>, was used to service the bathhouse. The Ghazaleh House is the only house in old Aleppo city which has a bath.

The *qa'a* consists of three *tazars* with one *'ataba* forming the shape of the letter "T". All nine walls and three ceilings have '*ajami*' panels with floral and geometrical motifs and inscriptions of poetry and proverbs. There is a fountain in the center of the '*ataba*'. The *iwan* is located in the south part of the main courtyard. It has an '*ajami*' ceiling with cornice. The northern hall is a rectangular room, the walls and ceilings are covered by '*ajami*' panels, which are dated by the names of the owners.

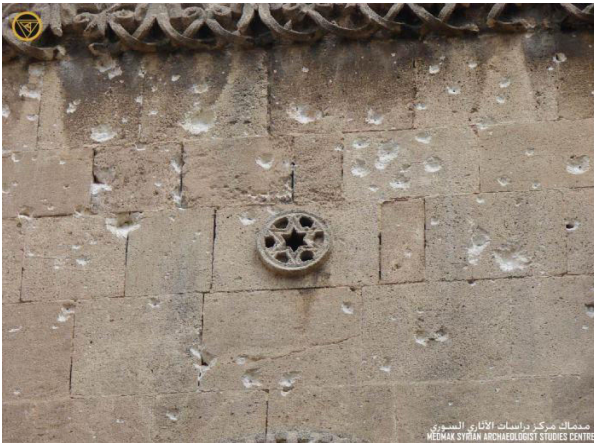
Figure 14: Bullet marks, Norhten façade, MEDMAK, 2015

The first photo (Figure 14) shows bullet marks on the norhten façade, and the second photo (Figure 16) of the south-west room shows that all the wooden panels with the ‘ajami cornice were stolen.

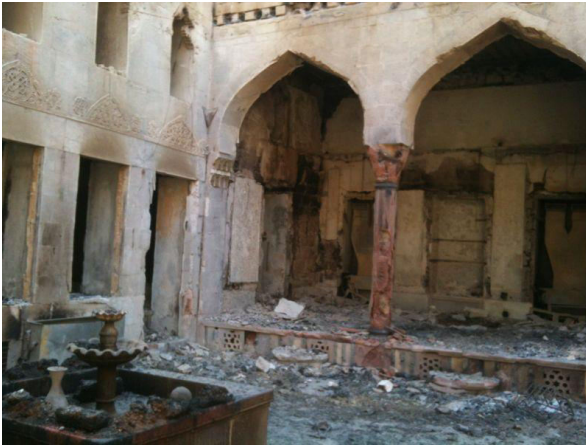
Figure 22: Zamria courtyard after fire, darzamaria.com

On September 29, 2012 the photo shows damage and destruction to the Zamaria House which was shelled many times (Figure 22). The house was burned completely and many parts were destroyed (Figure 23). The greatest loss in the Zamria House was the original polychrome wooden decorations from Ottoman era which covered all the walls and ceiling inside the rooms. All polychrome wooden decoration were burned and none of the pieces remains have been found.

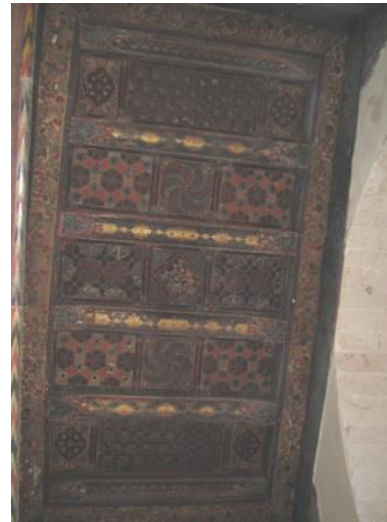
Figure 26: one of the qa'a ceiling, Rami, 2006

The *qa'a*: consists of three *tazars* with an '*ataba*' forming the shape of a "T". All nine walls and three ceilings have '*ajami*' panels with floral and geometrical motifs, and inscriptions of poetry and proverbs (Figure 26). The ceiling and walls of the *iwān* and its sunshade, the four rooms, and the *qa'a* are adorned with '*ajami*' panels.
